# **Phase 1-2 Cultural Resources Study, Historic Resources**

**83 Eucalyptus Lane (All Saints By-the-  
Sea Church), Montecito, California  
(APN 009-332-009)**

Post/Hazeltine Associates  
2607 Orella Street  
Santa Barbara, CA 93105  
(805) 682-5751  
[posthazeltine@cox.net](mailto:posthazeltine@cox.net)

August 27, 2015

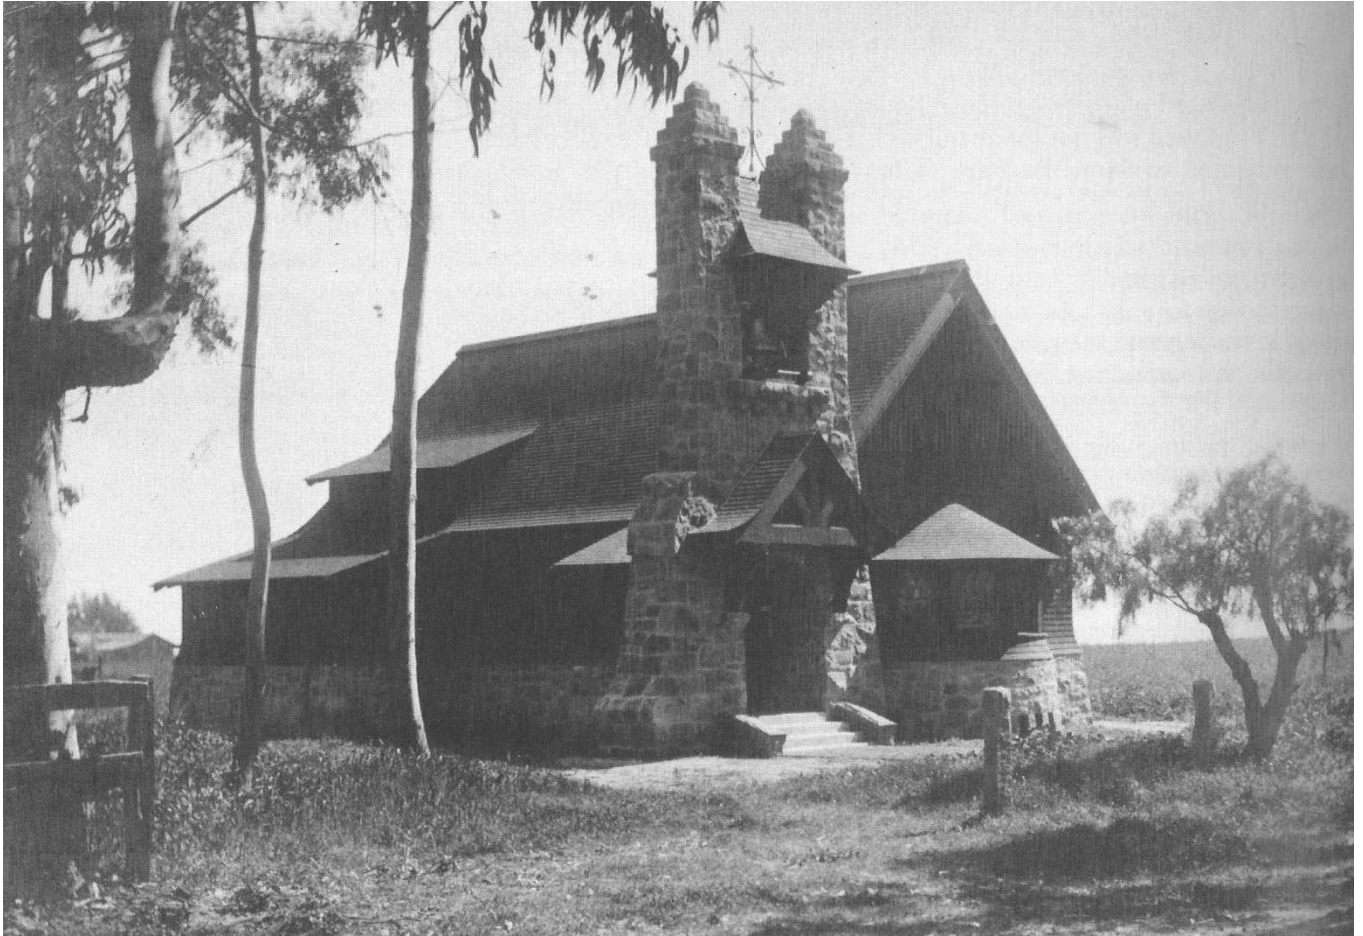
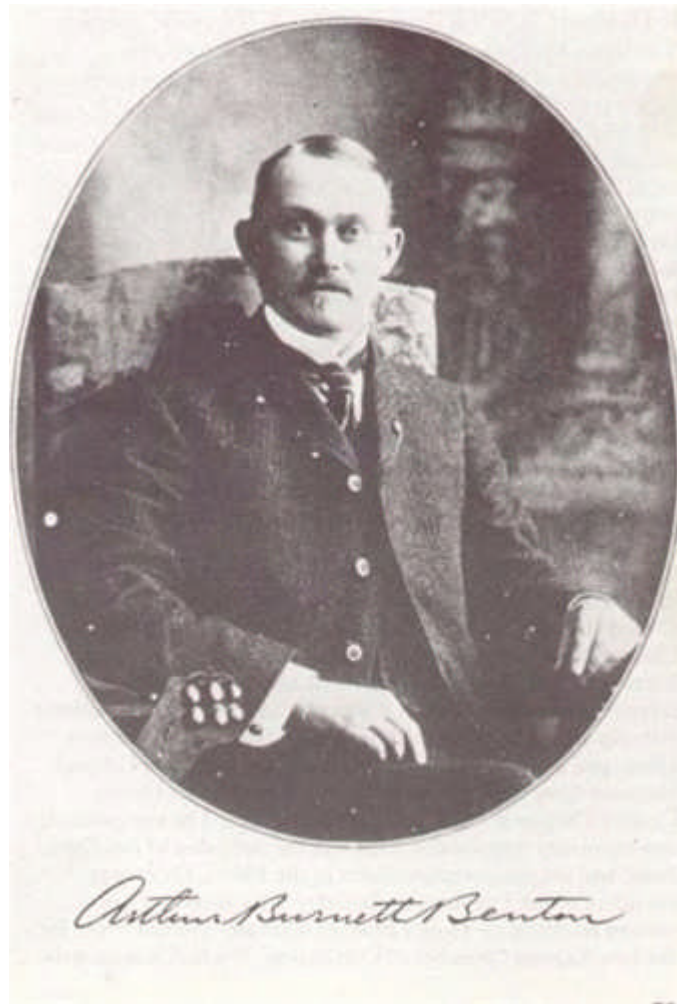
Figure 3  
All Saints By-the-Sea Church at 83 Eucalyptus Lane in Montecito  
Postcard of church shortly after completion  
Circa-1900-1915 (postcard)

Figure 4  
All Saints By-the-Sea Church at 83 Eucalyptus Lane in Montecito  
Postcard of church shortly after completion  
Circa-1900 (Myrick 1987: 130)

Originally the recessed wing and secondary entrance flanking the south side of the nave was capped by a shed roof (see Figures 3 & 4). In 1916 this wing was rebuilt with a front gable roof and a porch capped by open trusswork whose design emulated the roof over the main entrance to the church. The addition housed a study and choir room. The recessed wing at this end of the elevation was built in 1916.

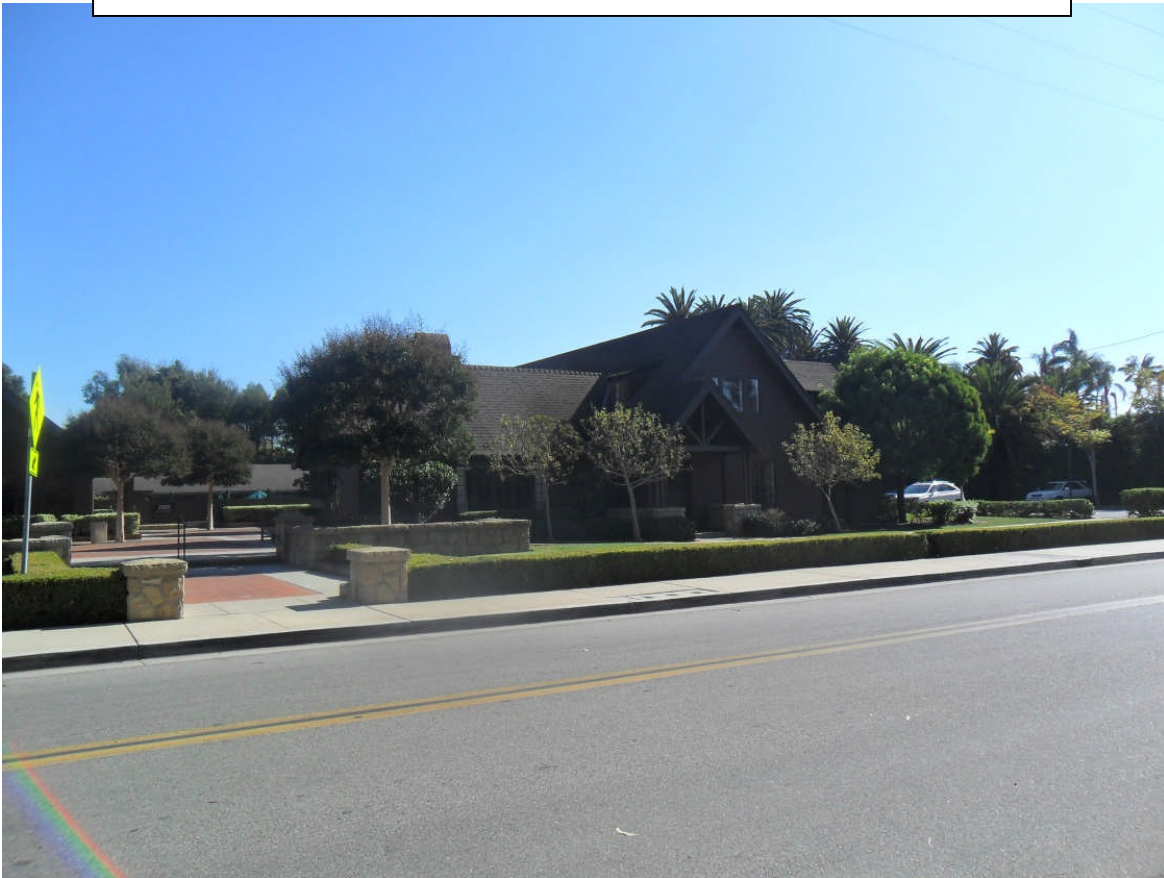
Figure 9  
All Saints By-the-Sea Church at 83 Eucalyptus Lane, Montecito  
Looking northeast

Improvements to the property include, in addition to the church (Figure 9), a detached Parish Hall (built 1929); a detached Centennial/Parish House (formerly the Rectory, built in 1934 and remodeled in 1998-1999); a detached Friendship Center/Sunday School (originally built as a Sunday school in 1949, additions were made in 1951, 1958 and additions and renovations in 1998-1999) (Figures 10,10a & 10b). The property's designed landscape features a paved parking lot and formal landscaping composed of trees, hedges, turf and specimen plants

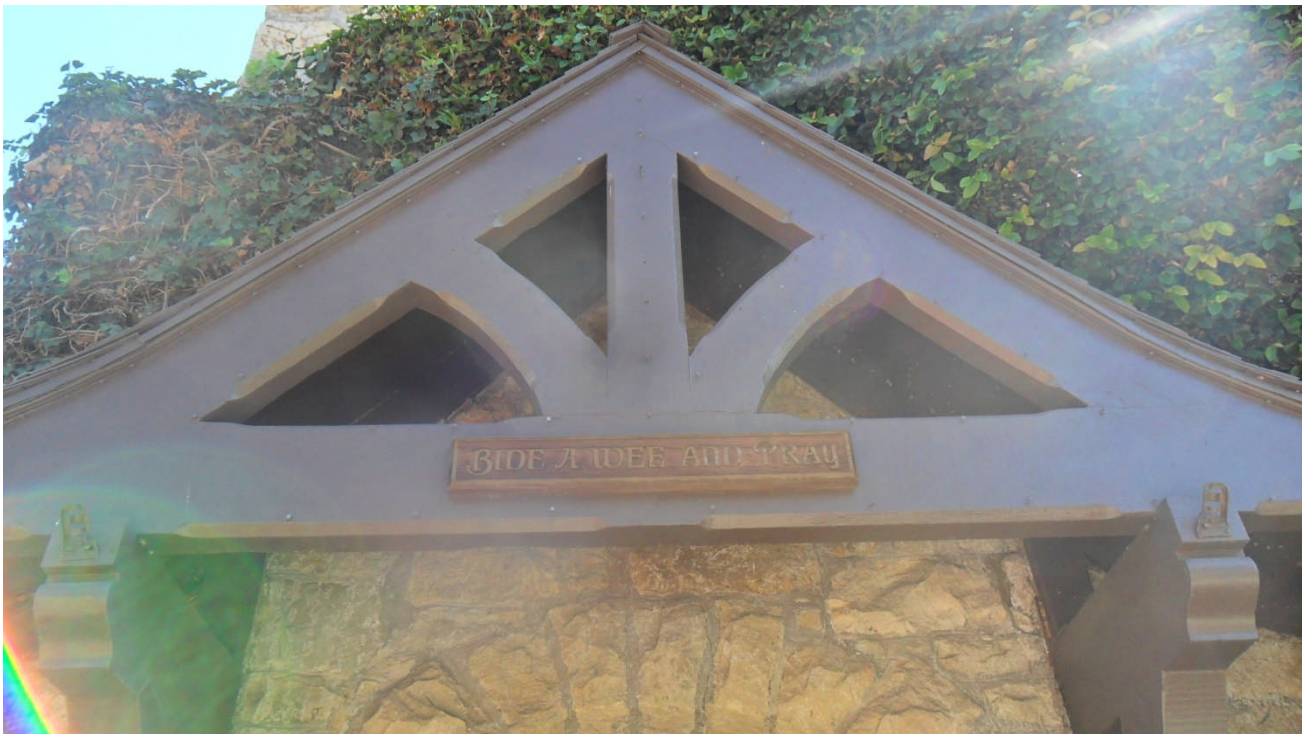
Figure 11  
All Saints By-the-Sea Church at 83 Eucalyptus Lane, Montecito  
West elevation of the church (primary façade)  
Looking east

Built in 1900, the wood frame and masonry Craftsman style church incorporates Gothic Revival style motifs (Figure 11). The church, which is essentially rectangular in configuration, is aligned on a west to east axis with the vestibule at its west end opening into the narthex and baptistery. The narthex opens into the nave which extends east to the sanctuary, which is flanked on its south side by the vestry and a small chapel. The church's picturesque massing, composed of steeply pitched roofs and a masonry bell tower set at the northwest corner of the building, is designed to emphasize the domestic scale of the building which recalls the appearance and character of a rural Gothic Revival English church as filtered through the sensibilities of Arthur Benton's interpretation of the Craftsman style.

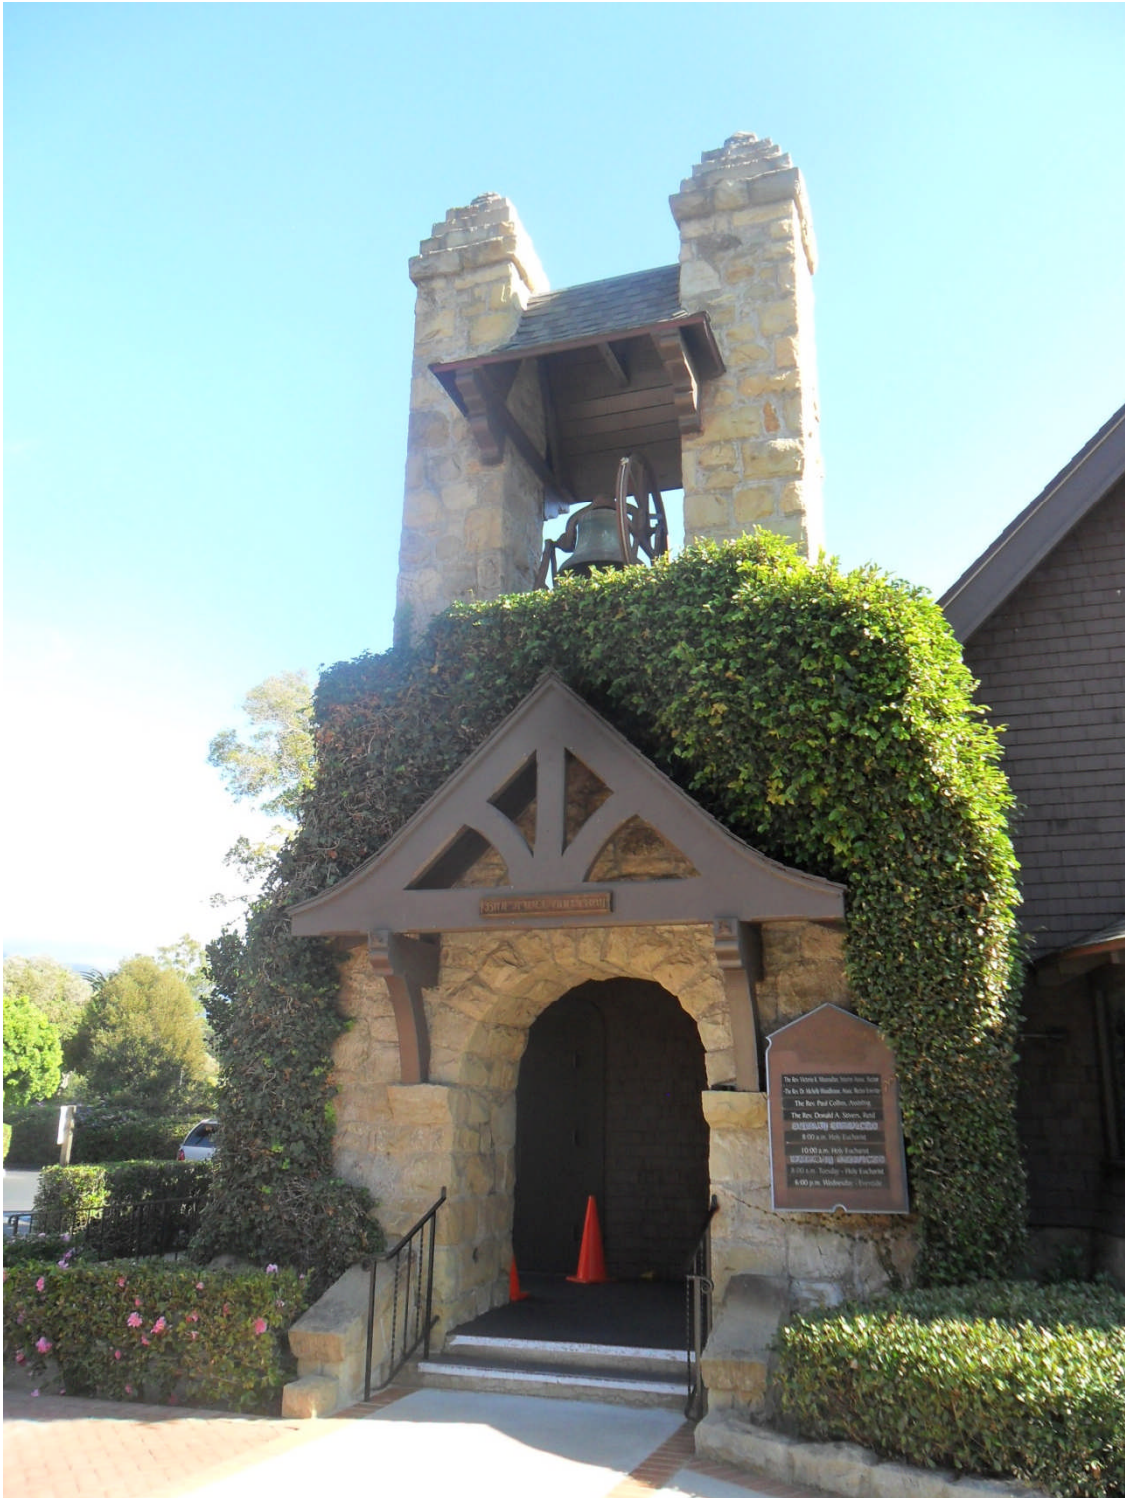
Figure 12  
West elevation(primary façade), detail of porch roof  
Looking east

The west elevation is the entrance façade of the building (Figures 12 - 14). Its picturesque massing is defined by the asymmetry of the elevation with the main front gable roof flanked on its north by a masonry bell tower composed of rectangular sandstone blocks housing a recessed entry porch at its base and a belfry. A series of steeply-pitched front gable roofs cap the main block of the church and the two recessed wings set off the south side of the elevation. The central gable is capped by a Celtic style cross. Wide wood plank fascias sheath the slightly projecting roof eaves. A semi-circular apse-like projection housing the baptistery at the centerpoint of the façade, is embellished with five lancet style stained glass windows. Three narrow lancet style stained glass windows are set

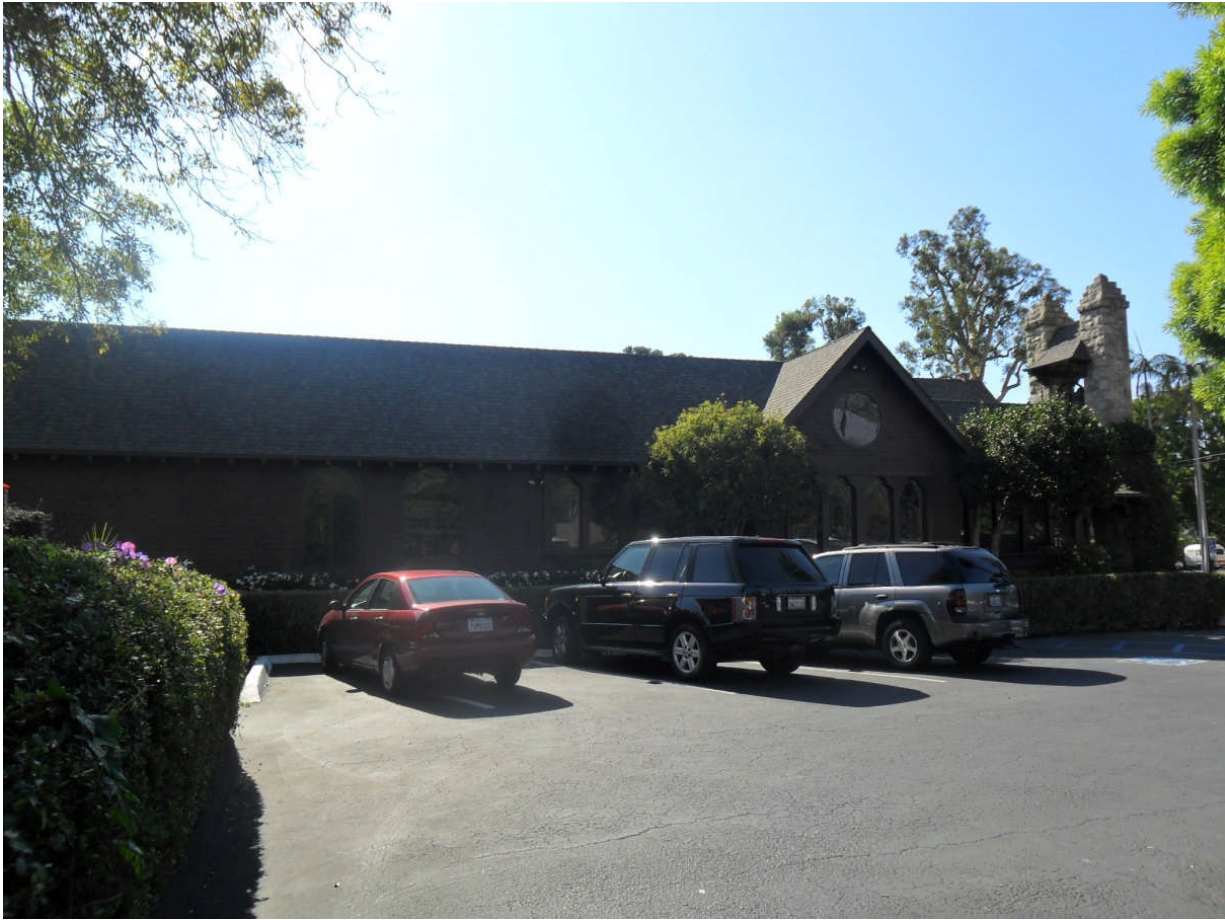
Figure 13  
All Saints By-the-Sea Church at 83 Eucalyptus Lane in Montecito  
North end of the west elevation (primary façade)

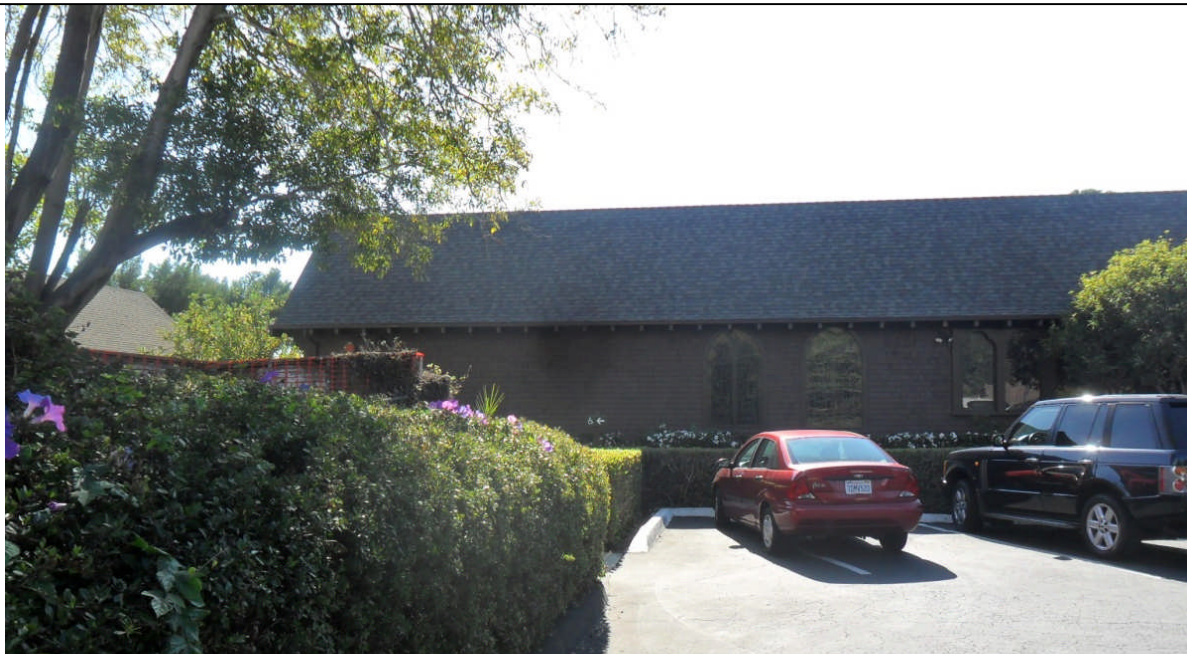
Figure 15  
All Saints By-the-Sea Church at 83 Eucalyptus Lane, Montecito  
North elevation  
Looking southwest

The north elevation is L-shaped in configuration, with the entry porch and belfry flanked on their east by an extension to the nave added in 1921 that has a front-facing gable roof (Figures 15 -18). At its east end the addition is flanked by the remaining section of the original exterior wall of the church which is capped by a side gable roof. The part of the elevation features a base of sandstone blocks capped by a shingled wall. Fenestration is comprised of a series of stained-glass windows set in arched openings. A circular stained glass window is set in the gable end of the wing added in 1921.

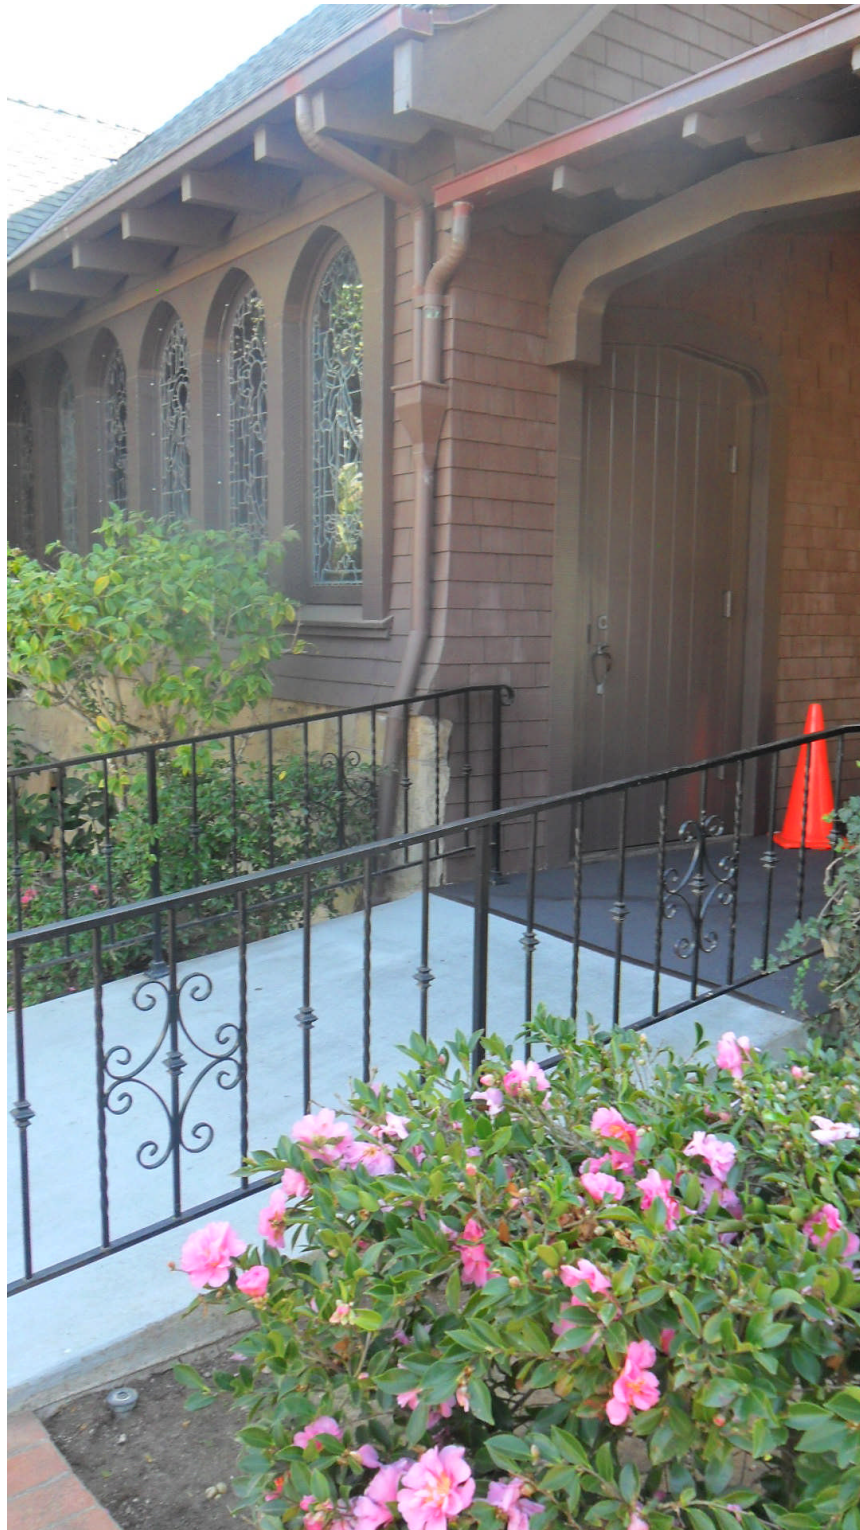
Figure 16  
All Saints By-the-Sea Church at 83 Eucalyptus Lane, Montecito  
North elevation  
Looking south

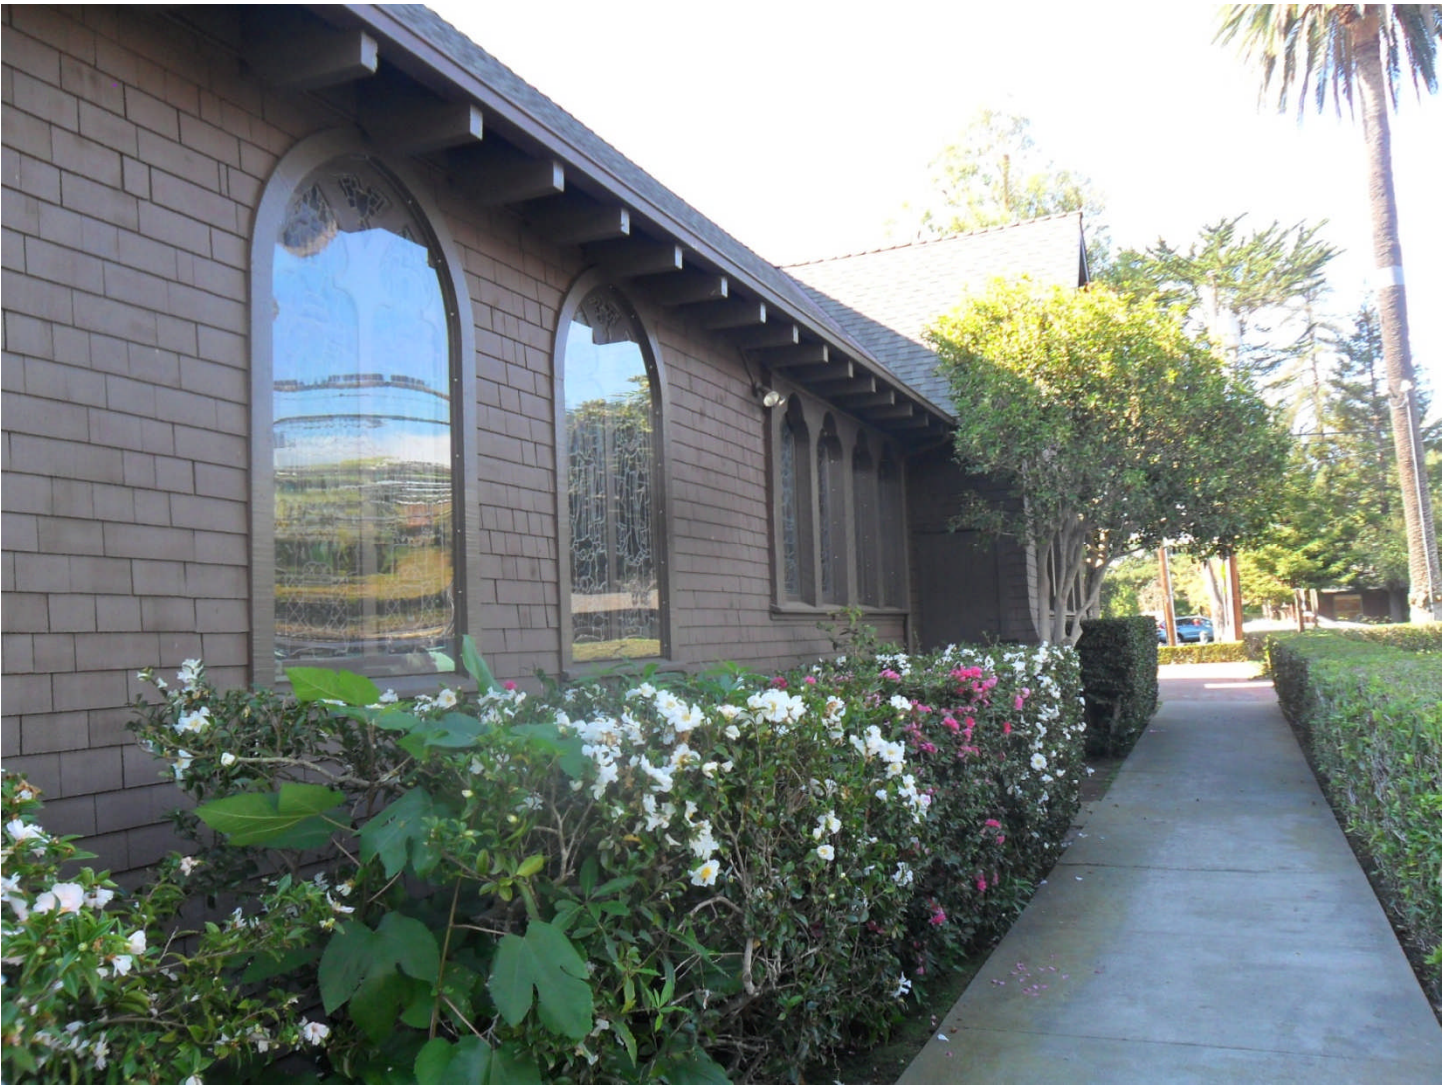
Figure 17  
All Saints By-the-Sea Church at 83 Eucalyptus Lane, Montecito  
North elevation (west end of elevation with entrance porch into church)  
Looking southwest

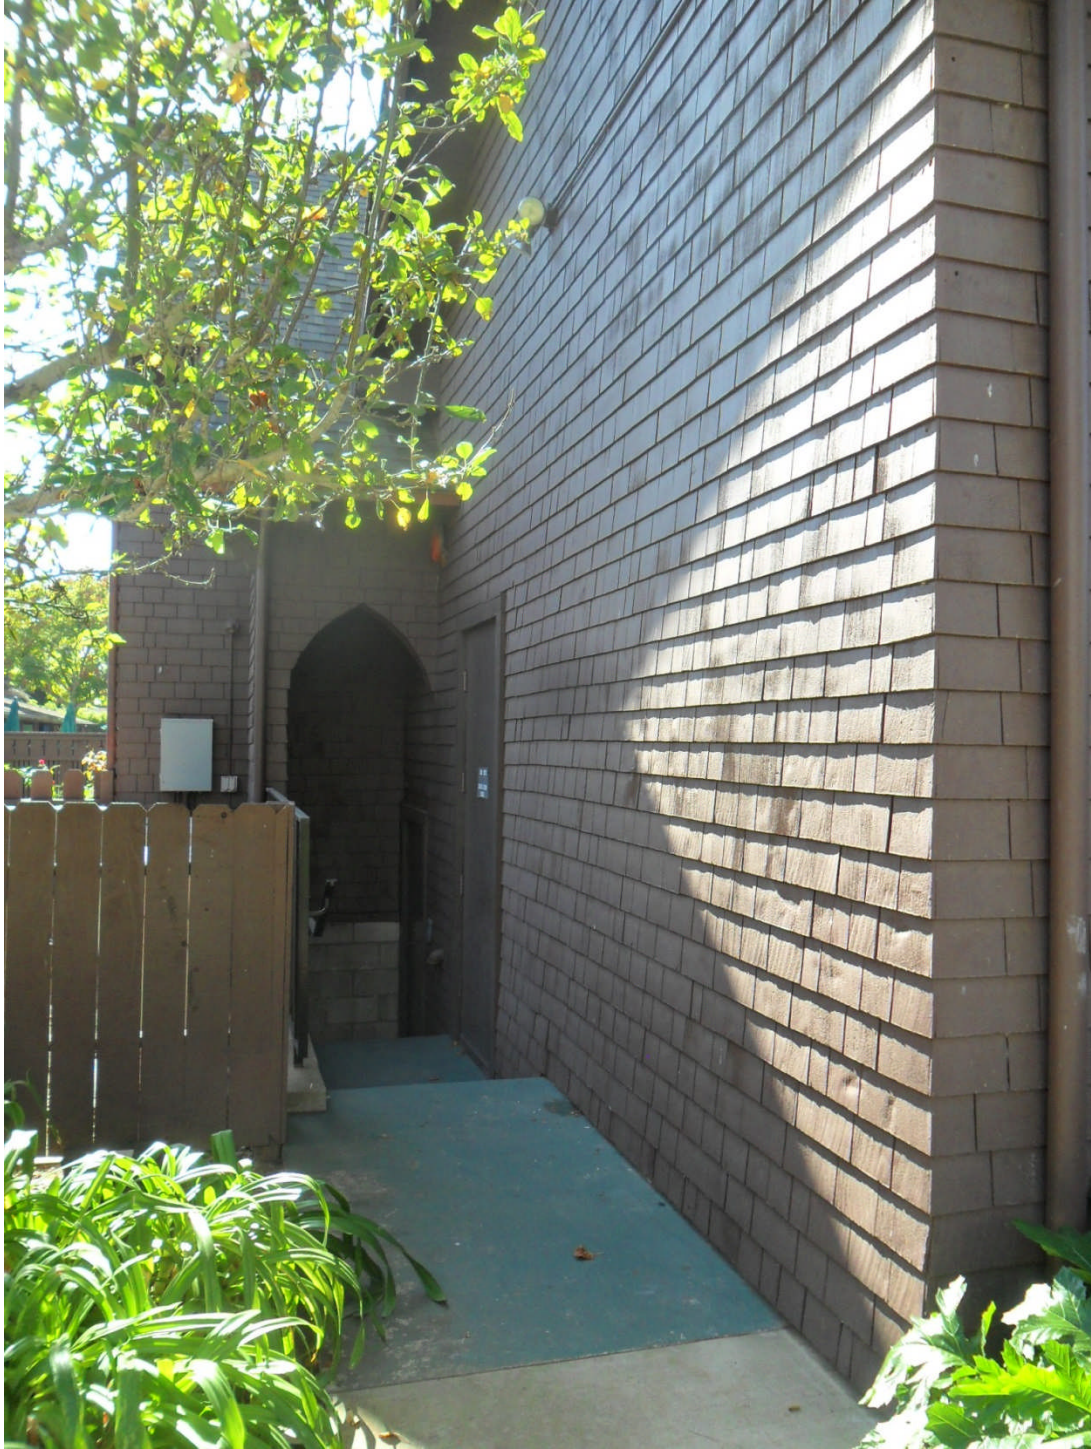
Figure 18  
All Saints By-the-Sea Church at 83 Eucalyptus Lane, Montecito  
North elevation  
Looking west

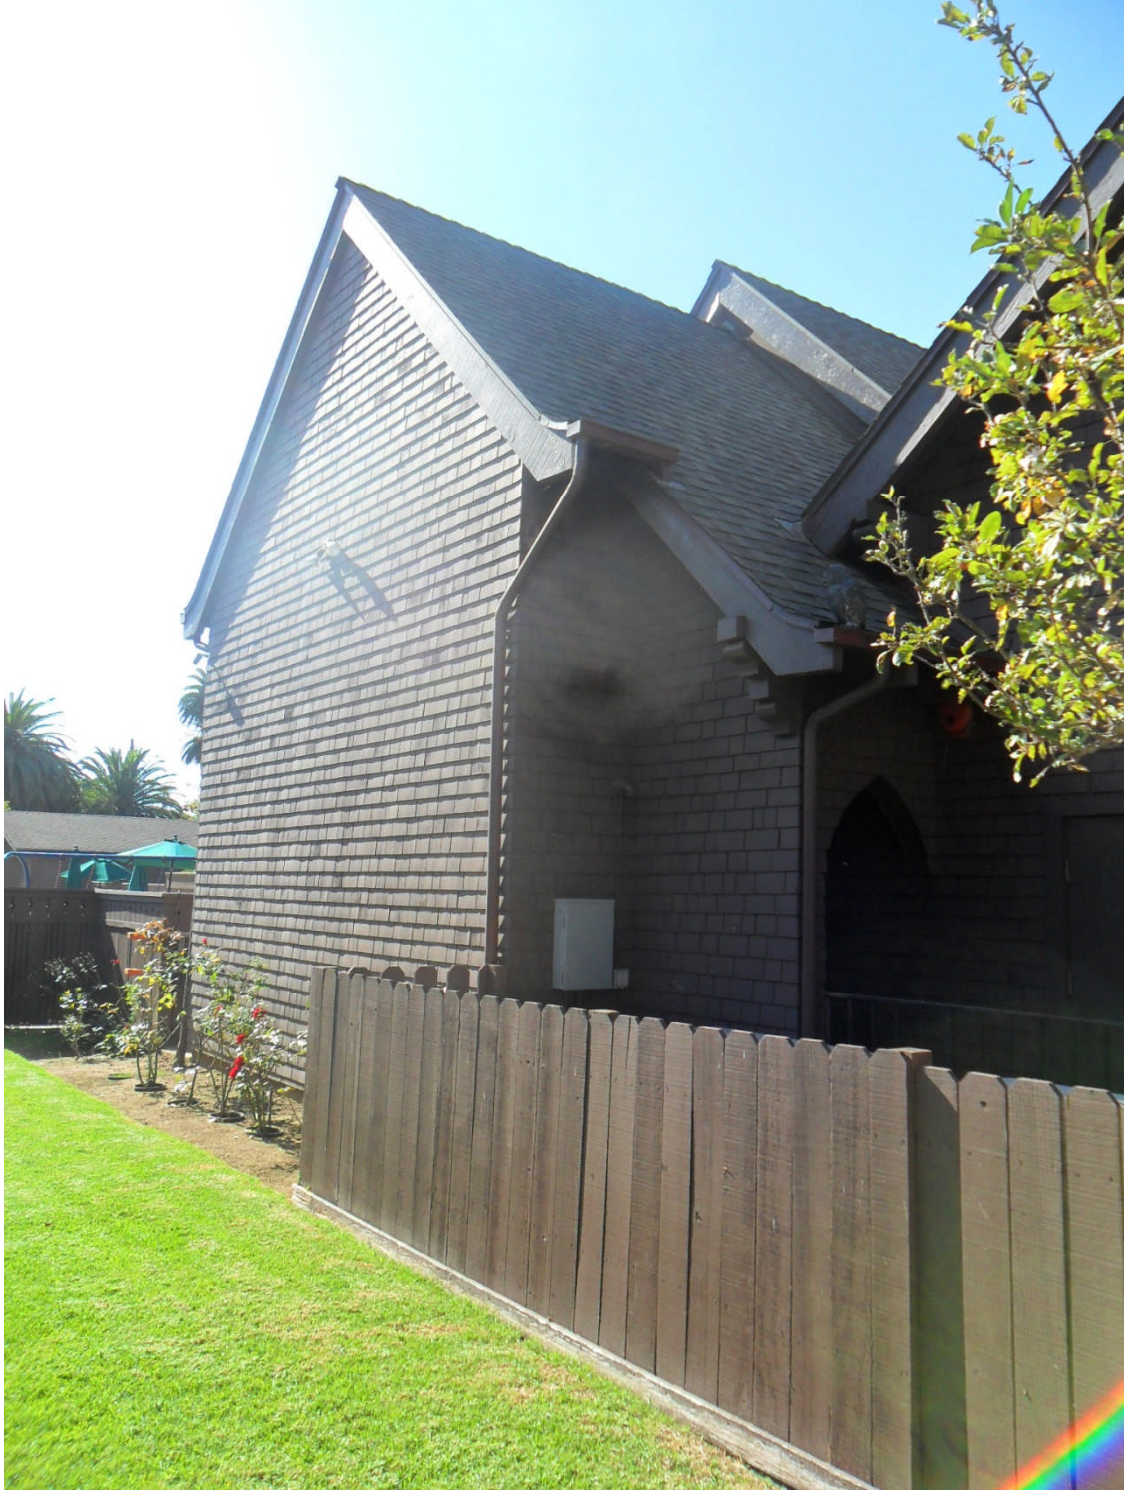
Figure 19  
All Saints By-the-Sea Church at 83 Eucalyptus Lane, Montecito  
East Elevation, north end  
Looking south

The east elevation has an irregular footprint composed of the centrally-placed sanctuary end of the church flanked on its south by the recessed end of the vestry and on its north by the slightly recessed end of the 1921 addition to church (Figures 19 &20). The entire elevation is clad in wood shingles. Fenestration is

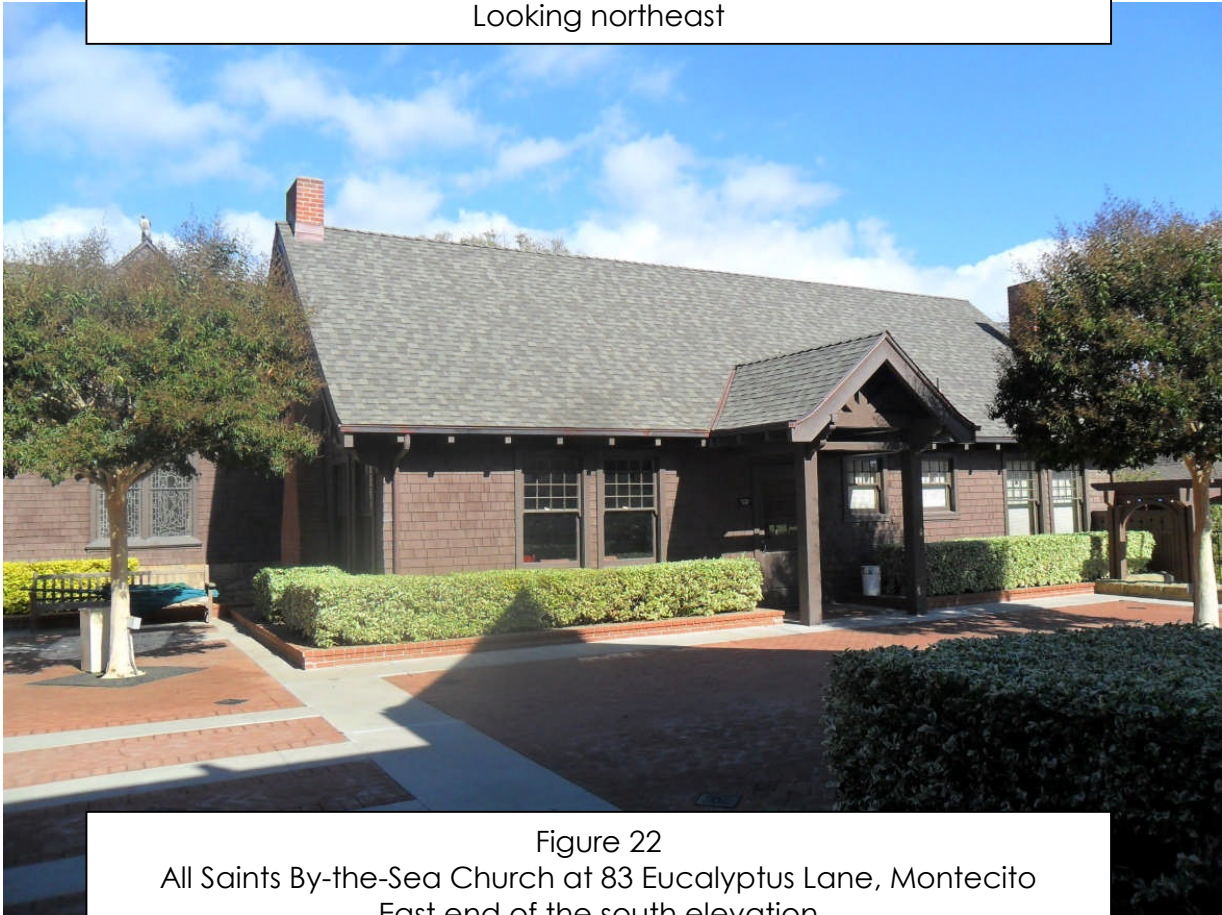
Figure 21  
All Saints By-the-Sea Church at 83 Eucalyptus Lane, Montecito  
West end of the south elevation  
Looking northeast

The south elevation is L-shaped in configuration with the south elevation of the church flanked on its east by a projecting wing built in 1916 housing a study for the rector and a choir room (Figures 21 & 22 and see Figure 14). The nave and aisles of the church are capped by a steeply-pitched side-gable roof; its fenestration is composed of stained glass windows set in arched reveals. The choir room and study are capped by a steeply-pitched side gable roof. A porch, capped by a front-gable roof supported by corbelled wood timbers, shelters a glazed panel wood door that provides access to the choir room.
